Fukushima Daiichi Nuclear Plant Event Summary

LLW Repository Ltd

Event Summary

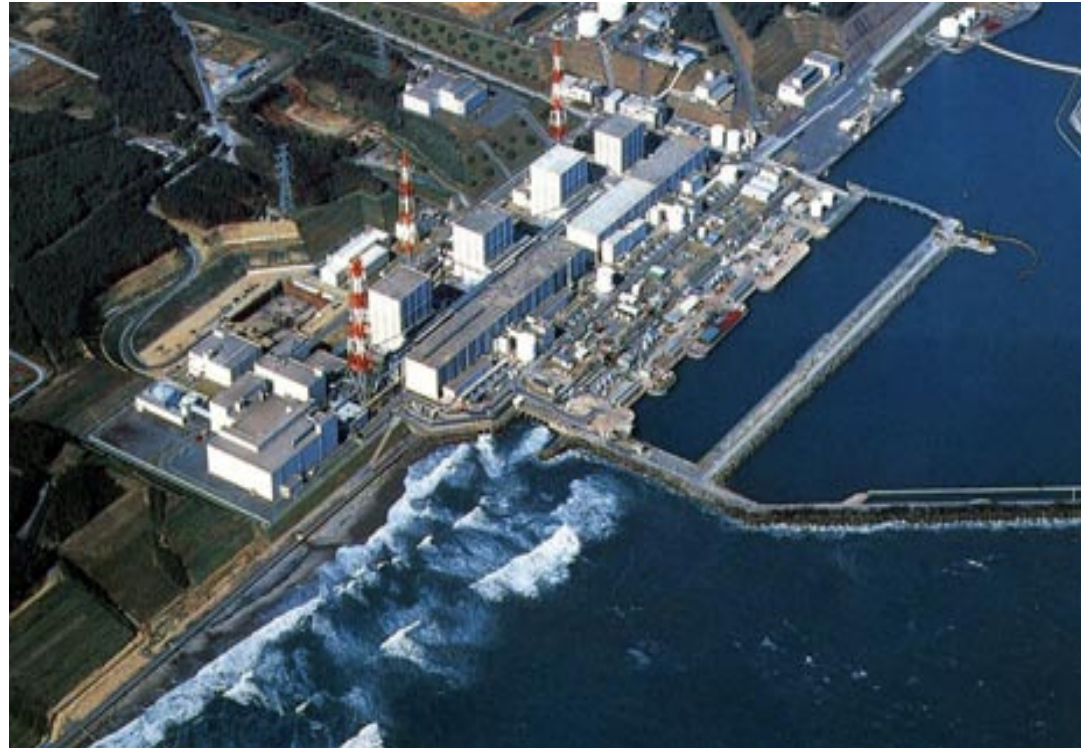
- Six Boiling Water Reactors (BWR)
- Built 1970-1979
- 3 running at the time
- 3 in outage

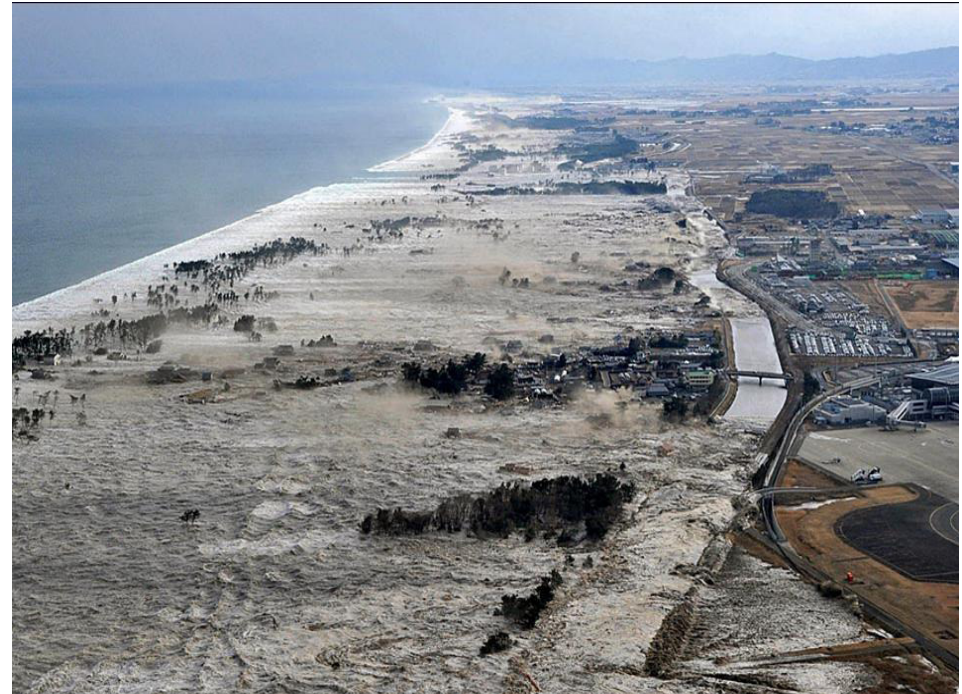
- Inundated 420 miles of eastern coast of Japan
- Arrived ~ 60 minutes after earthquake
- Height approximately 14m
- Well beyond what the plant was designed to withstand

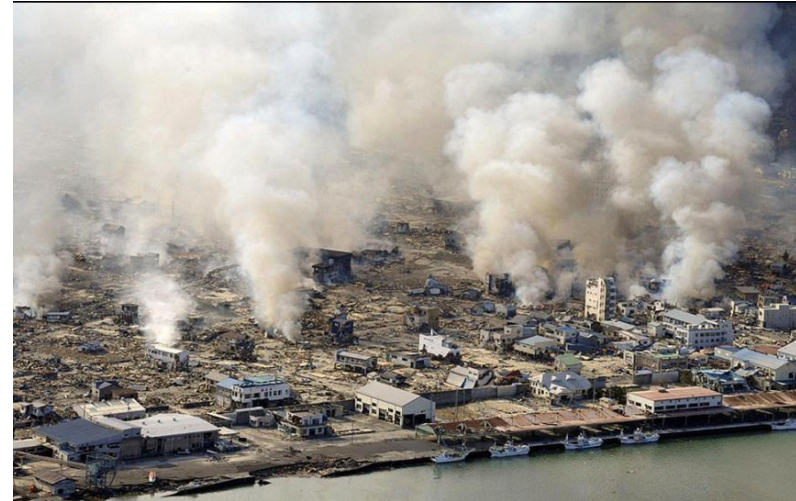
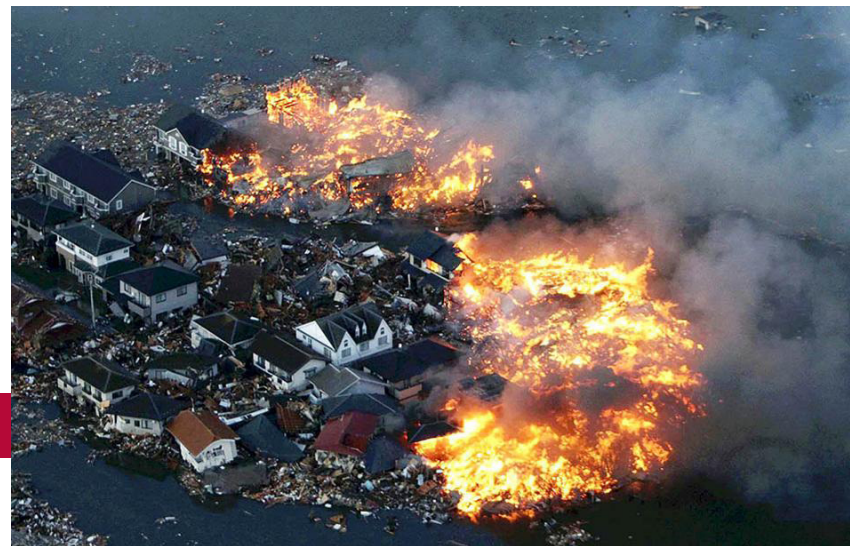
Enormous non-nuclear impact

- 14,000 Dead
- 10,000 Missing
- 300,00 homeless
- Entire towns levelled or washed into the ocean

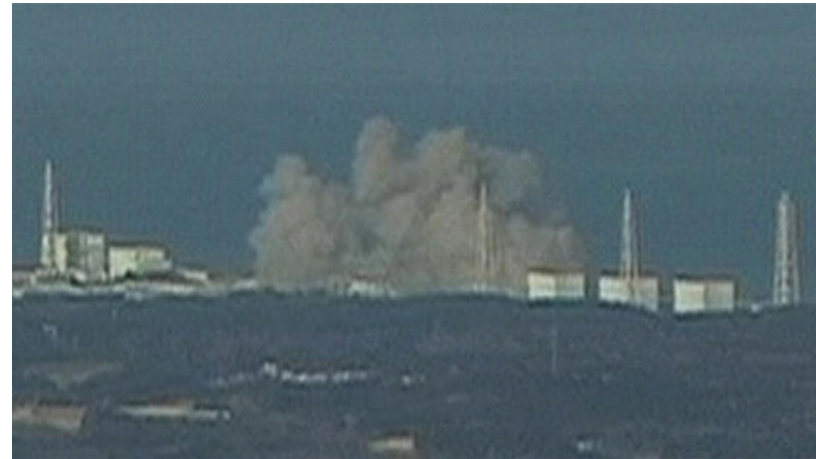
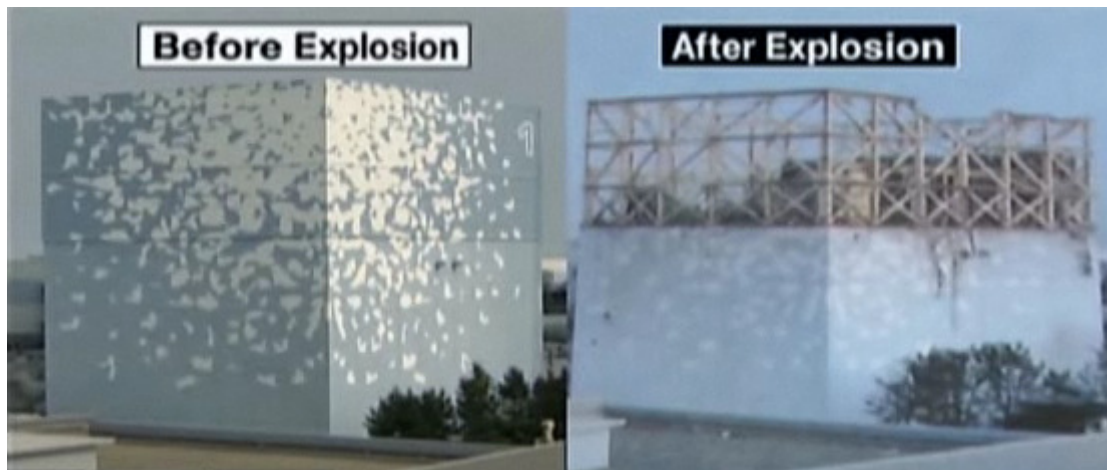
Hydrogen Detonation at Unit 1
